Folding Mirror Mechanism Anomaly Report

1 Anomaly Description

1.1 Summary

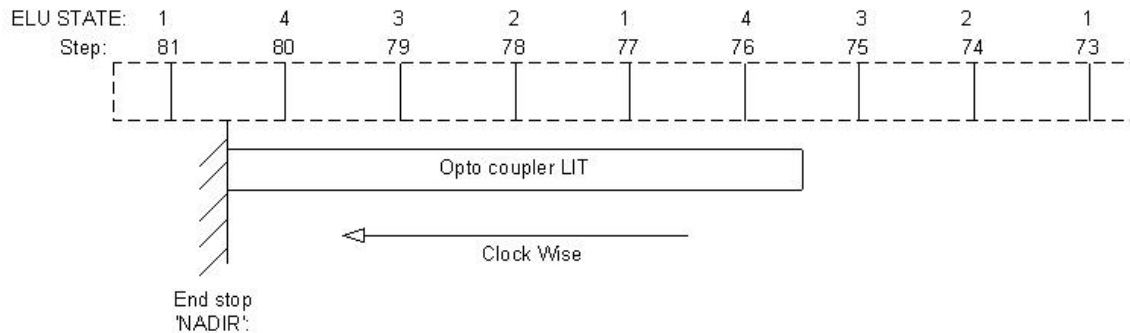
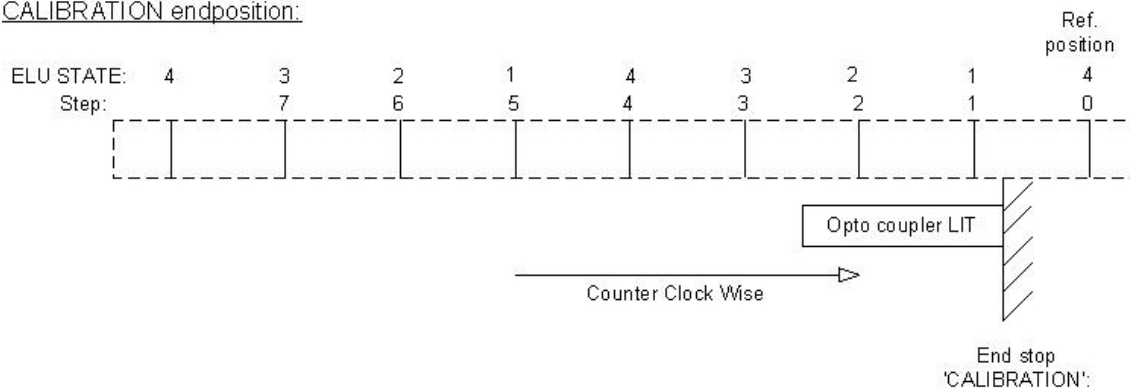
Figure 2 The motor phase and opto-coupler status as a function of mechanism position

Figure 2 shows the relation between mechanism position, motor phase and opto-coupler status. For calibration measurements the initial FMM position is assumed to be unknown. After resetting the motor phase to STATE1 the FMM is moved from this unknown position to calibration position zero (STATE4) by commanding 85 steps (multiple of 4 plus 1) counter clock wise. In case the FMM bounces against the end-stop (with an assumed number of 4 steps), indicated by a dark status of the opto-coupler, the FMM is moved four additional steps counter clock wise from position four to position zero. Since the end-stop is located between positions zero and one, the FMM is assumed to push against the end-stop during calibration measurements. When the calibration measurement is finished, the FMM is moved to nadir position 79 by commanding 79 steps clock wise.

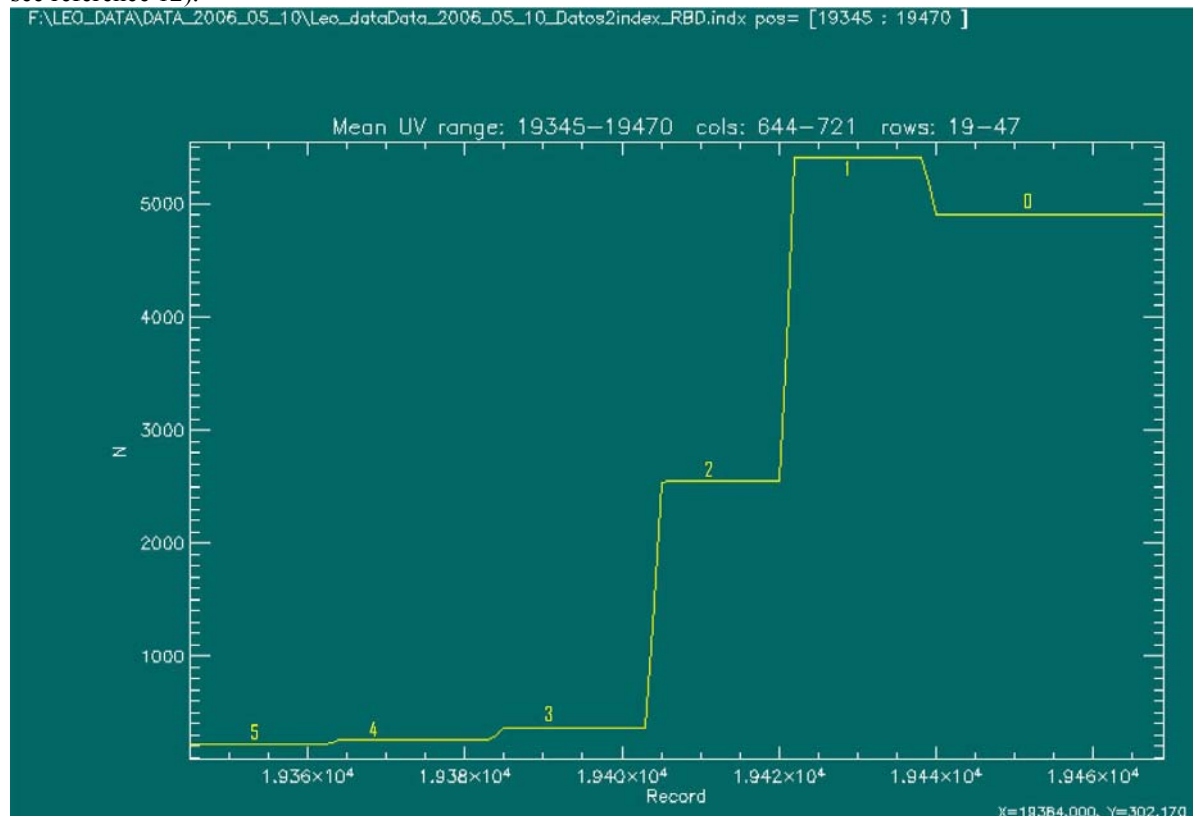
All tests were successful. During all tests the FMM showed nominal behaviour. There is no loss of steps observed when moving the FMM from nadir position to calibration position and vice versa. There is no indication for an opto-coupler problem. No bouncing against the calibration end-stop takes place when commanding the FMM step-by-step instead of 85 steps at once. When using the WLS, the WLS signal is highest at FMM position 1 whereas position 0 (the calibration position) was expected (see *Figure 3* and for more details see reference 12).

Figure 3 UV1 average WLS signal from 17:45:34 (#19345) – 17:49:44 (#19470). The FMM position goes from 5 → 4 → 3 → 2 → 1 → 0. The signal in position 0 is obviously lower than at position 1. The signal change from position 1 → 0 is about 20% from the signal change from position 2 → 1. The signal change from position 1 → 0 is about 25% the signal change from position 3 → 2.

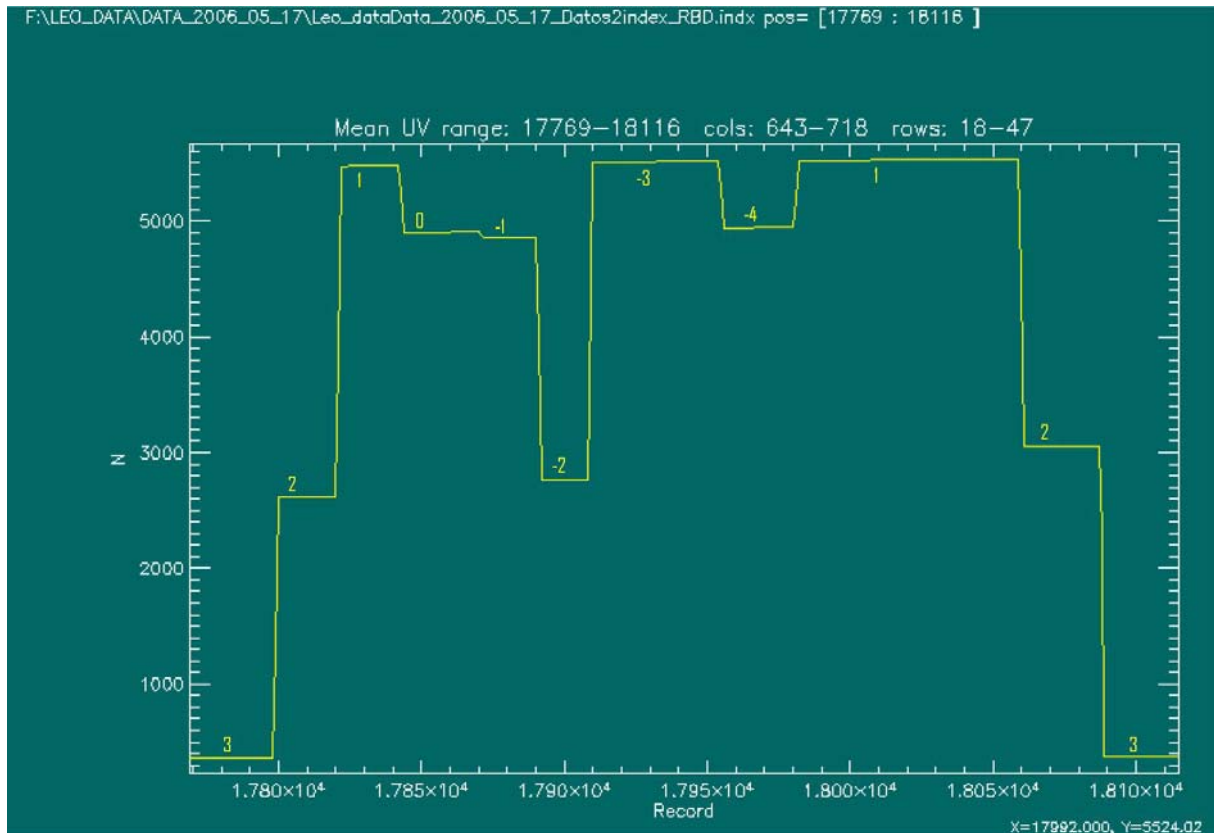
It turns out that the FMM position during a calibration measurement is just in front of the calibration end-stop and not at the calibration end-stop (see *Figure 4* and for more details reference 9).

Figure 4 UV1 average WLS signal from 16:16:42 (#17769) – 16:28:18 (#18117). The FMM position goes from 3 → 2 → 1 → 0 → -1 (actually 0) → -2 (actually 2) → -3 (actually 1) → -4 (actually 0) → 1 → 2 → 3. A small signal change can also be observed when going from position 0 → -1, which is unexpected, because the FMM was assumed to be pushing against the calibration end-stop at position 0. The signal change between positions 0 and -1 is about 1.5%. Which leads to the conclusion that during calibration measurements the FMM is positioned just before the calibration end-stop. This figure also confirms that the FMM jumps back when FMM position commanded from position -1 to position -2. Obviously at commanded position -2 (ELU state 2) the preferred energetic mechanical state is at FMM position 2, which also has ELU state 2.
