# Correction of rainfall series in the Netherlands resulting from leaky rain gauges

T. Brandsma, J.J. Beersma, J.W. van den Brink, T.A. Buishand,  
R. Jilderda, A. Overeem

De Bilt, 2020 | Technical report; TR-387

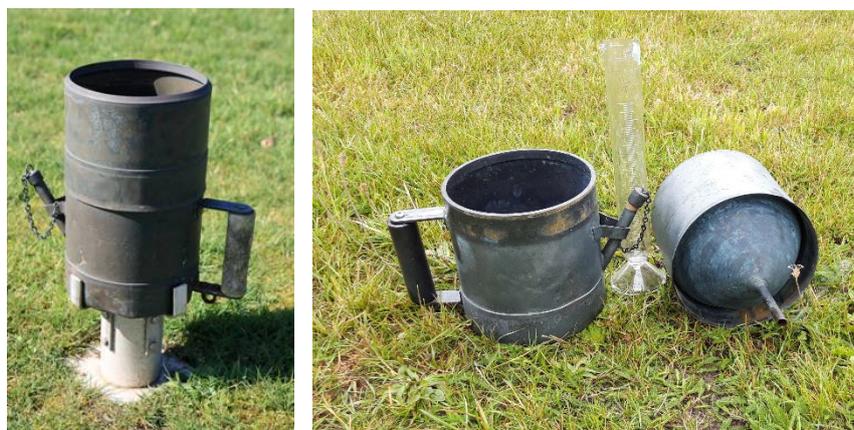
*Photo 1 Left: KNMI manual rain gauge (collecting surface 200 cm<sup>2</sup>) consisting of a reservoir (lower part) and a funnel (upper part). A ring with a height of 5 cm is attached to the funnel to clamp the funnel on the reservoir. The rim is at a height of 40 cm above ground level. Right: Funnel and reservoir taken apart and the measuring glass. Before each measurement the funnel is removed from the reservoir and the reservoir is emptied in the measuring glass.*

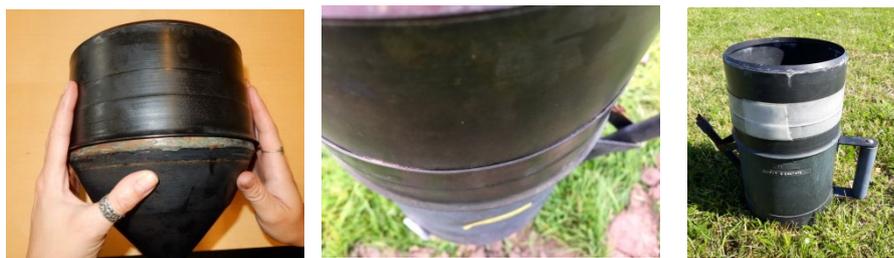
*Photo 2: From left to right: gauge with ring shifted upward, gauge repaired using spot welding but with gaps between the welding spots, and gauge sealed with special tape.*

the rings were now firmly attached to the funnel, the repair caused gaps in between the welding spots. Unfortunately, by then this was not recognized as a problem. Later it became clear that the gaps could result in measuring too much rainfall. Through the gaps, rainfall splashing against the outer side of the funnel could find its way into the reservoir.

Awaiting the installation of newly fabricated gauges (without shortcomings) all 320 gauges were sealed in June-July 2017 using a special tape to prevent leakage. If sealing was not possible because of a loose and shifted ring<sup>3</sup>, the rain gauge was replaced by another sealed gauge. At eleven stations an old type rain gauge was still being used. These were non-leaky gauges and did not need repair.

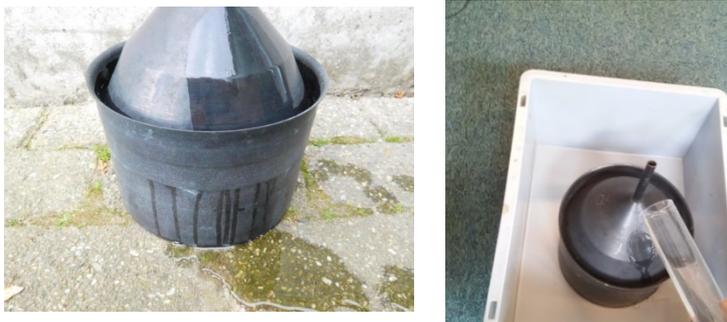
*Photo 3 Left: Rain gauge funnel turned upside-down, showing a (potentially) leaky rain gauge. Right: Performing the leakiness test. Note that water is added in the space between the funnel and the ring.*

We devised a simple test to determine the potential leakiness of a gauge in the field. When turned upside-down, water could be added in the space between the funnel and the ring. If water was flowing out, the gauge was

considered (potentially) leaky with the magnitude of the flow being a first indication of leakiness. The procedure was as follows:

1. Place the funnel, turned upside-down, in a plastic container.
2. Use the measuring glass of the gauge to pour a volume of water equivalent to 4 mm of rain in the space between the funnel and the ring (this volume almost completely fills this space) and start a stopwatch.
3. Measure the time till all water has flown out of the space between the funnel and the ring, if this occurs within two minutes, and go to step 5. Else, go to step 4.
4. Remove the funnel from the container after two minutes and use the measuring glass to determine the amount of water in the container.
5. Calculate the leakiness in mm/min by dividing the amount of water in the container by the time it took to get the water in the container.

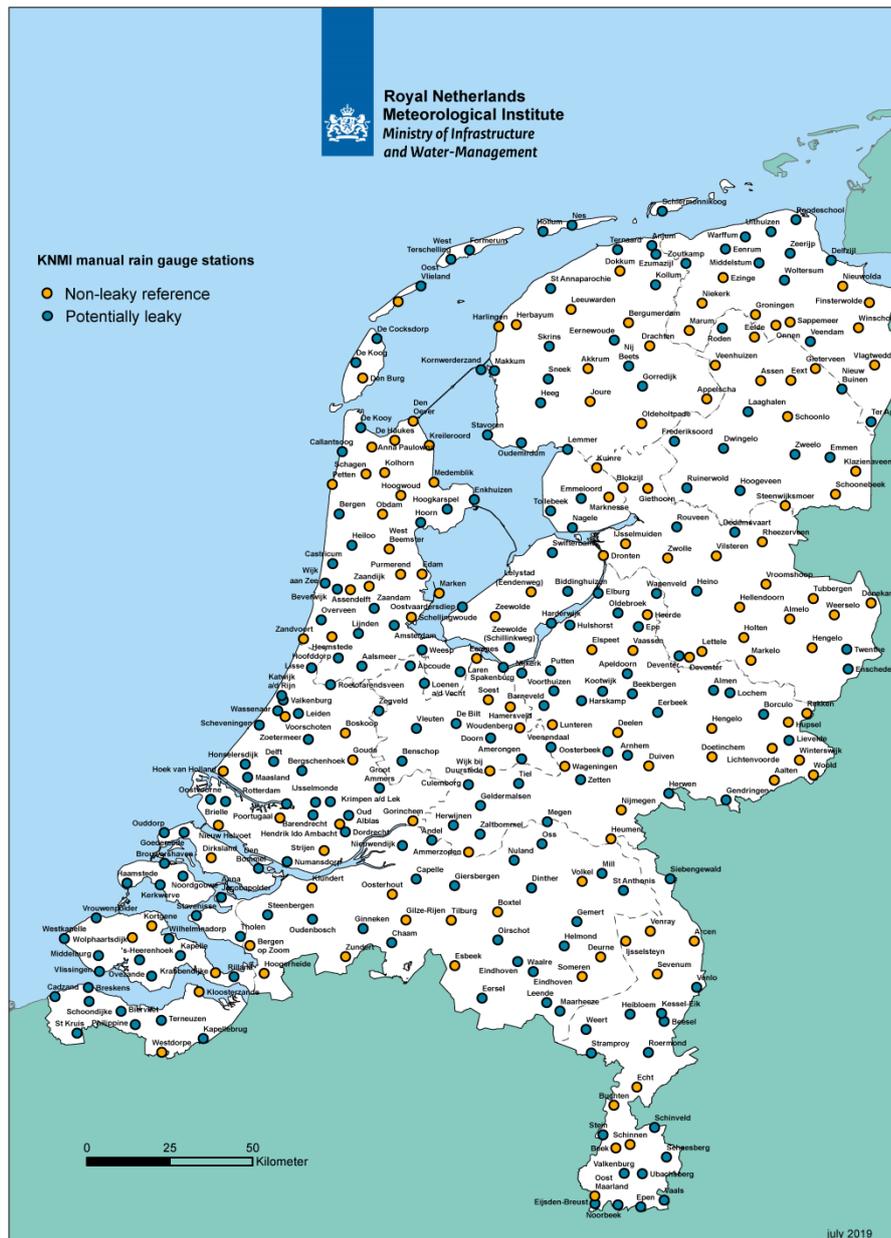
Figure 3: Map of the 131 non-leaky reference stations (yellow) and the 320- 131 = 189 stations with potentially leaky gauges (blue) in the manual daily rainfall network (MN).

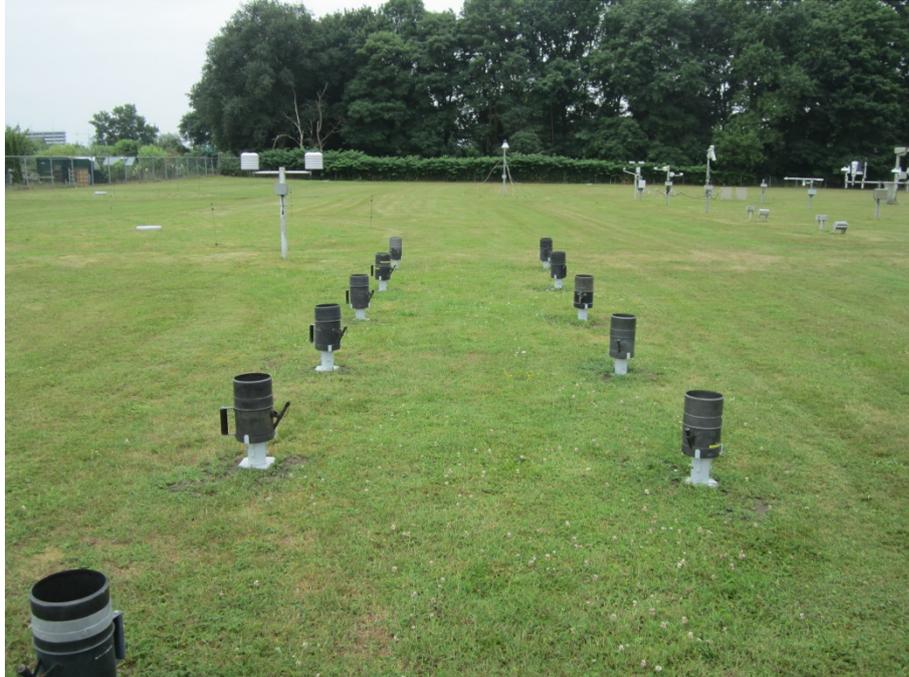
*Photo 4: Experiment at the KNMI test site in De Bilt comparing 11 manual rain gauges, performed in the period June 2017 – May 2018. Among the gauges are two old type gauges, four new type gauges, two new type gauges repaired with spot welding, two new type gauges with shifted rings, and a sealed new type gauge (lower left).*

In addition to the experiments described above and the study of metadata, a field experiment at the KNMI test site in De Bilt was set up to investigate the differences in rainfall between the gauges in more detail. The purpose of the experiment was to increase our understanding of the effect of leakiness and to value the statistical corrections. Eleven manual rain gauges were compared. The results are described in Appendix B. A large day-to-day variance of the effect of leakiness was found, related to the weather conditions and the placement of the funnel on the reservoir which varies from day to day. This implies that at best statistical corrections are possible, because information on exact weather conditions and the placement of the funnel on the reservoir are virtually unknown for the manual rain gauges.

The field experiment further shows that the effect of leakiness is generally larger in winter than in summer. This can be attributed to the higher wind speeds and lower rainfall intensities (smaller drop sizes) in winter, resulting in a larger angle of inclination of the rainfall. The most leaky gauge in the field received up to 40% more rainfall (for some winter months) than the non-leaky gauges.

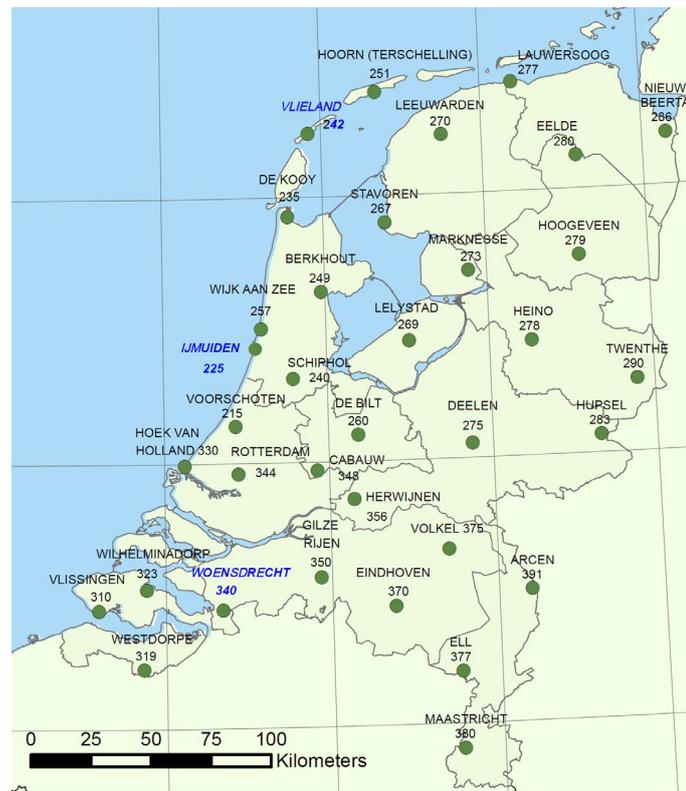
Figure 4: Positions of the 35 automatic weather stations. The three stations with names and numbers in blue have no rain gauge.

Automatic rain gauges are installed at 32 of the 35 AWS locations in the Netherlands (see Figure 4 for locations). They are mostly situated in rural open areas. Rainfall is measured using the so-called KNMI rain gauge (see e.g., Wauben, 2004, for a detailed description). This electric gauge is of the floating type and measures rainfall with a time resolution of 12 seconds. The funnel and reservoir are heated if the air temperature falls below 4°C in order to melt solid precipitation. The gauge has a calibration interval of 14 months. Currently, precipitation values are in situ aggregated to 1-min, 10-min and 1-hour totals and subsequently archived at the KNMI headquarters in De Bilt. Only the hourly data is validated by the validation division and is used in this research. The validated hourly data is publicly available via the KNMI website.

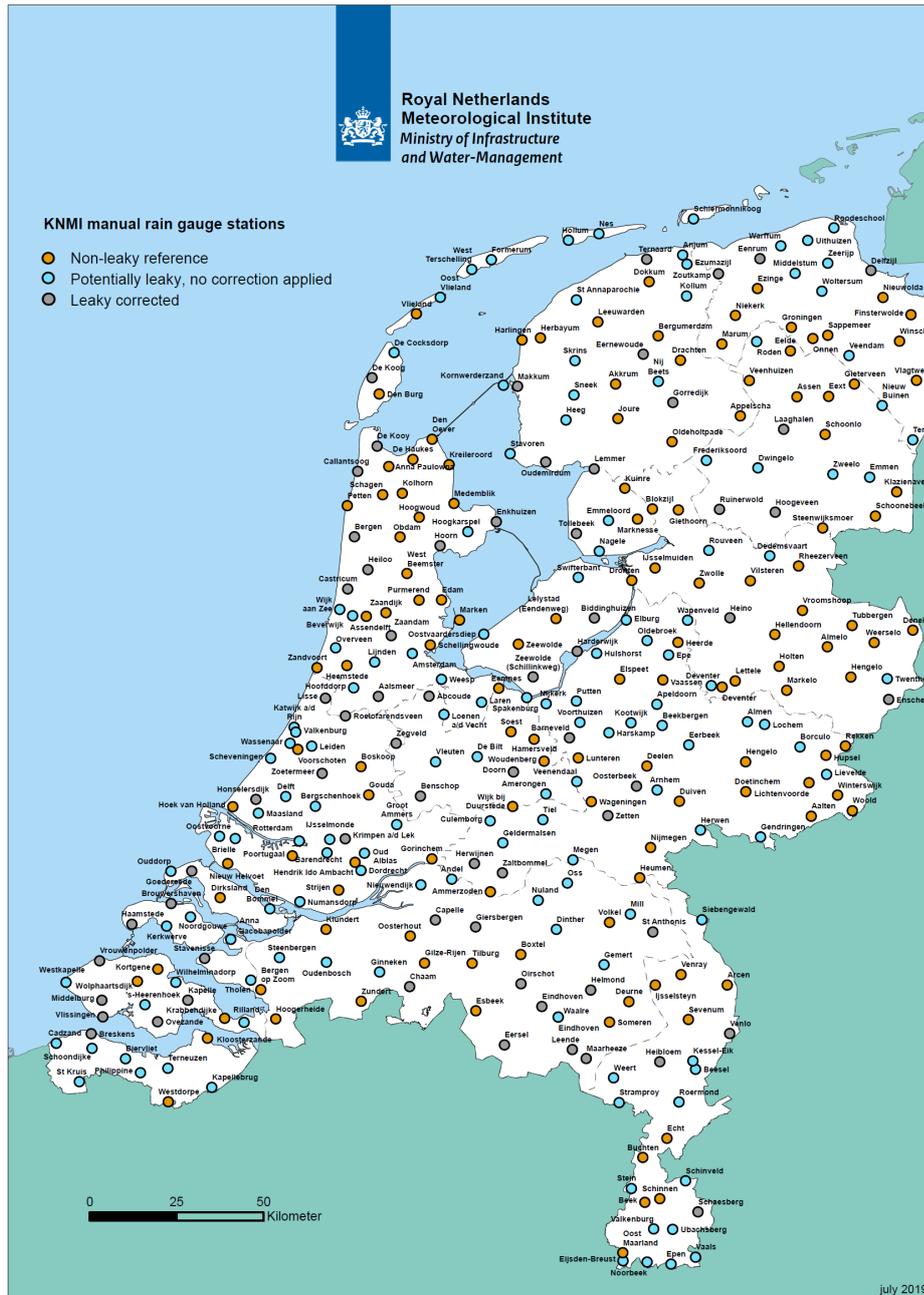
Figure 12: Map of non-leaky reference stations (yellow), potentially leaky stations, no correction applied (light blue), and leaky stations with corrected data (grey).

We compared the rainfall series of all stations with potentially leaky rain gauges with a reference series. Each reference series consisted of the mean rainfall of the 15 nearest non-leaky stations. For 65 of the 320 stations (operational during 2012-2017) a correction was applied to the data for (part of) the 2012-2017 period. These stations measured too much rainfall because water splashing against the sides of the funnel entered into the reservoir. The daily time series of the 65 stations were corrected. Since the publication of this report, the corrected series replace the original series in the KNMI climatological database and the derived operational products were adapted as well. Figure 12 shows the locations of the 65 stations with

corrected series together with the locations of the reference stations and the potentially leaky stations where no correction was applied.

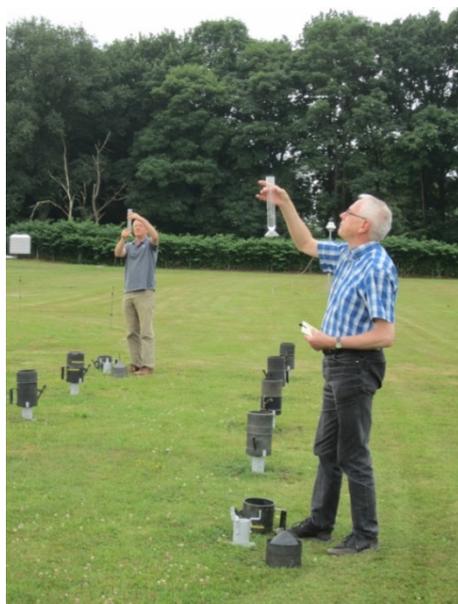
Photo 5: KNMI staff tapping the eleven manual rain gauges at 8:00 UTC.

For the intercomparison of the gauges, the non-leaky old type rain gauge R1

was used as a reference. Percentage differences were calculated as:
