Royal Netherlands  
Meteorological Institute  
*Ministry of Infrastructure  
and Water Management*

# Comparison of KNMI and Hellmann manual rain gauges

De Bilt, 2022 | Technical report; TR-399

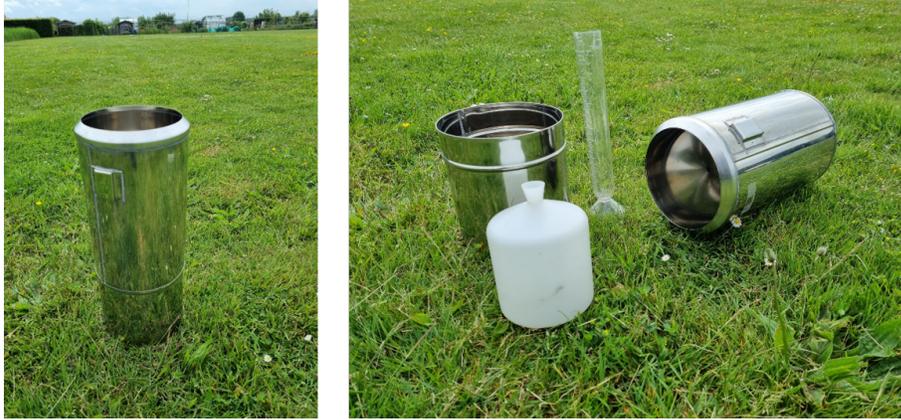
Figure 2.1: Left: Hellmann manual rain gauge (collecting surface 200 cm<sup>2</sup>) consisting of a reservoir (lower part) and a funnel (upper part). Right: Funnel and reservoir taken apart, the plastic container and the measuring cylinder. For the manual evaluation of the daily precipitation amount, the funnel is removed from the reservoir. Thereafter the container is emptied into the measuring cylinder.

For the experiment we ordered two different versions of the Hellmann manual rain gauge, both constructed according to the requirements of the German weather service (DIN 58666). The first version consists of two gauges made of stainless steel in use by the DWD. These were obtained from Franz Ketterer Feinmechanik, Sölden. The second version consists of two gauges made of zinc, produced by Lambrecht and obtained from Bakker & Co, Zwijndrecht. The DWD version of the Hellmann gauge is shown in Figure 2.1.

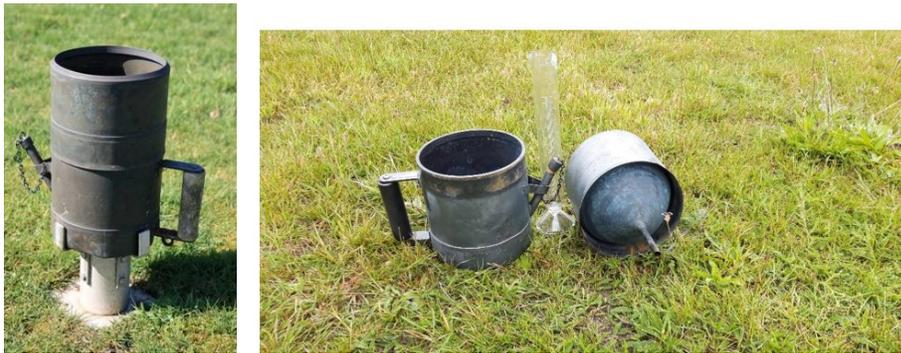
Figure 2.2: Left: KNMI manual rain gauge (collecting surface 200 cm<sup>2</sup>) consisting of a reservoir (lower part) and a funnel (upper part). Right: Funnel and reservoir taken apart and the measuring cylinder. Before each measurement the funnel is removed from the reservoir and the reservoir is emptied into the measuring cylinder.

The four Hellmann gauges have been compared with five KNMI gauges. Two of these gauges were of the old design ( $< 2012$ ) and three of the new design ( $\geq 2012$ ). Figure 2.2 shows an example of an old design KNMI gauge. Note that the Hellmann gauge has a separate plastic container in the reservoir. Rainfall is collected in this container and emptied into the measuring cylinder. Excess rainfall is stored in the reservoir. For the KNMI gauge, rainfall is collected in the reservoir and emptied in the cylinder. Using a separate container in the reservoir may reduce evaporation, as it protects the stored rainfall from heating up.

For the new design KNMI gauge, the height of the reservoir was increased to contain 150 mm of rainfall compared to the 115 mm of rainfall previously. The poles carrying the gauge were lowered 3.5 cm to leave the rim at the operational height of 40 cm above ground level. As only these poles have been used in the experiment, the rim of the old design gauge was at about 37 cm above ground level during the experiment.

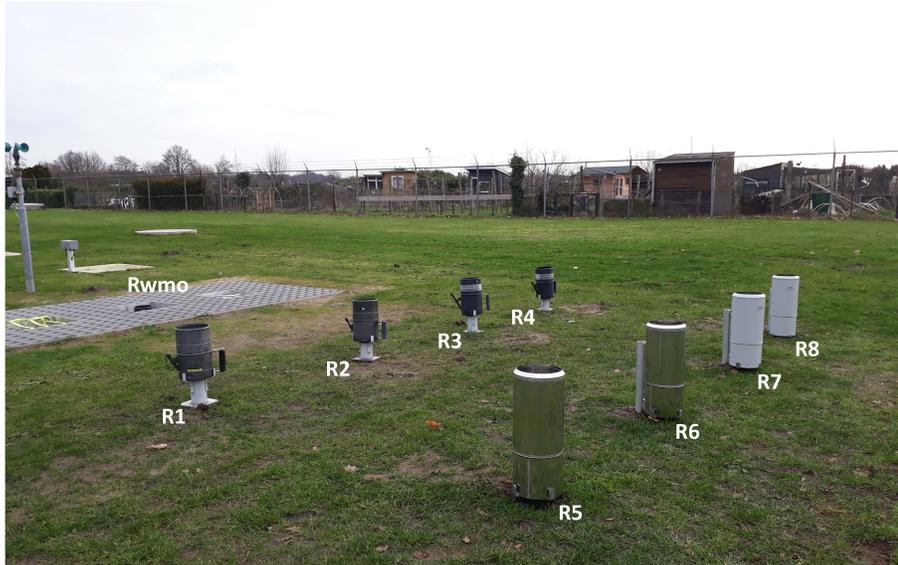
Figure 2.3: Experimental set-up at the KNMI test field in De Bilt. Photograph taken in northeasterly direction. Table 2.1 contains a description of the gauges.

Figures 2.3 and 2.4 show a photograph and map of the setup at the KNMI test field. Details of the gauges are in Table 2.1. One of the new design KNMI gauges was placed in a WMO pit, all other gauges were in a set-up on the field. The gauge in the WMO pit is meant to give an impression of the wind error
